## Disabling Clutch Orifice of SUBARU IMPREZA GDB

CLUTCH ORIFICE mechanism has been installed as original function in SUBARU IMPREZA GDB to prevent a rapid clutch engagement.

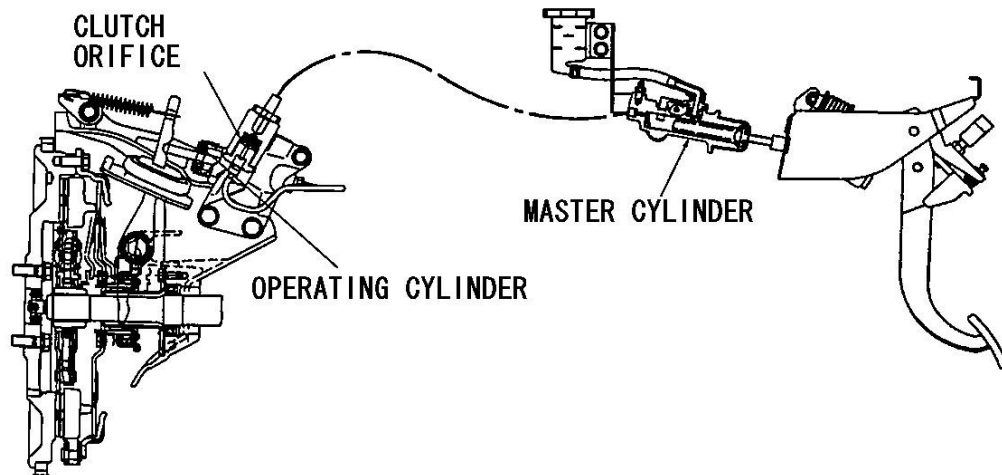
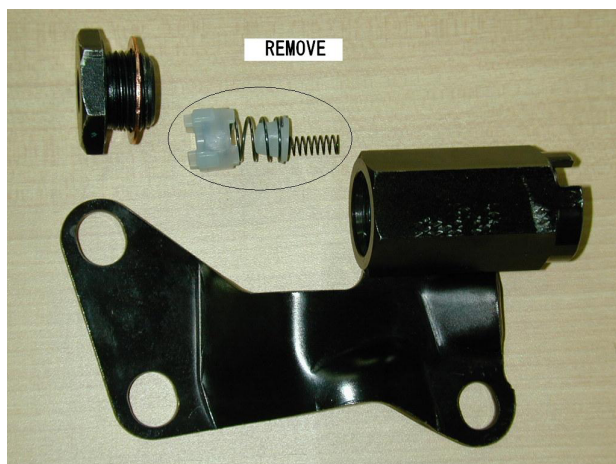
- 1) Please detach the clutch orifice, which located next to clutch operating cylinder.
- 2) Loosened a screw of the orifice on the operating cylinder side.
- 3) Please note that there are springs inside of the orifice.
- 4) Please remove the parts (2 springs and 2 plastic parts) from the orifice
- 5) Please make sure that washer is attached to the screw and tighten up the screw to prevent any leakage of clutch fluid.
- 6) Attach the orifice to the vehicle as before, and please extract air from the clutch tube to ensure that clutch works correctly.

However, this function might accelerate wear rate of the carbon disc or cause a slipping of the clutch, we recommend to disable the function by following procedure.
